Cell windows in the high activity examination facility contained a zinc bromide (ZnBr) solution which needed to be removed. The facility had been used for testing and examining fuel from the reactors on site. The existing drainage system left a residue in each window after use which would have required substantial additional work to clear.

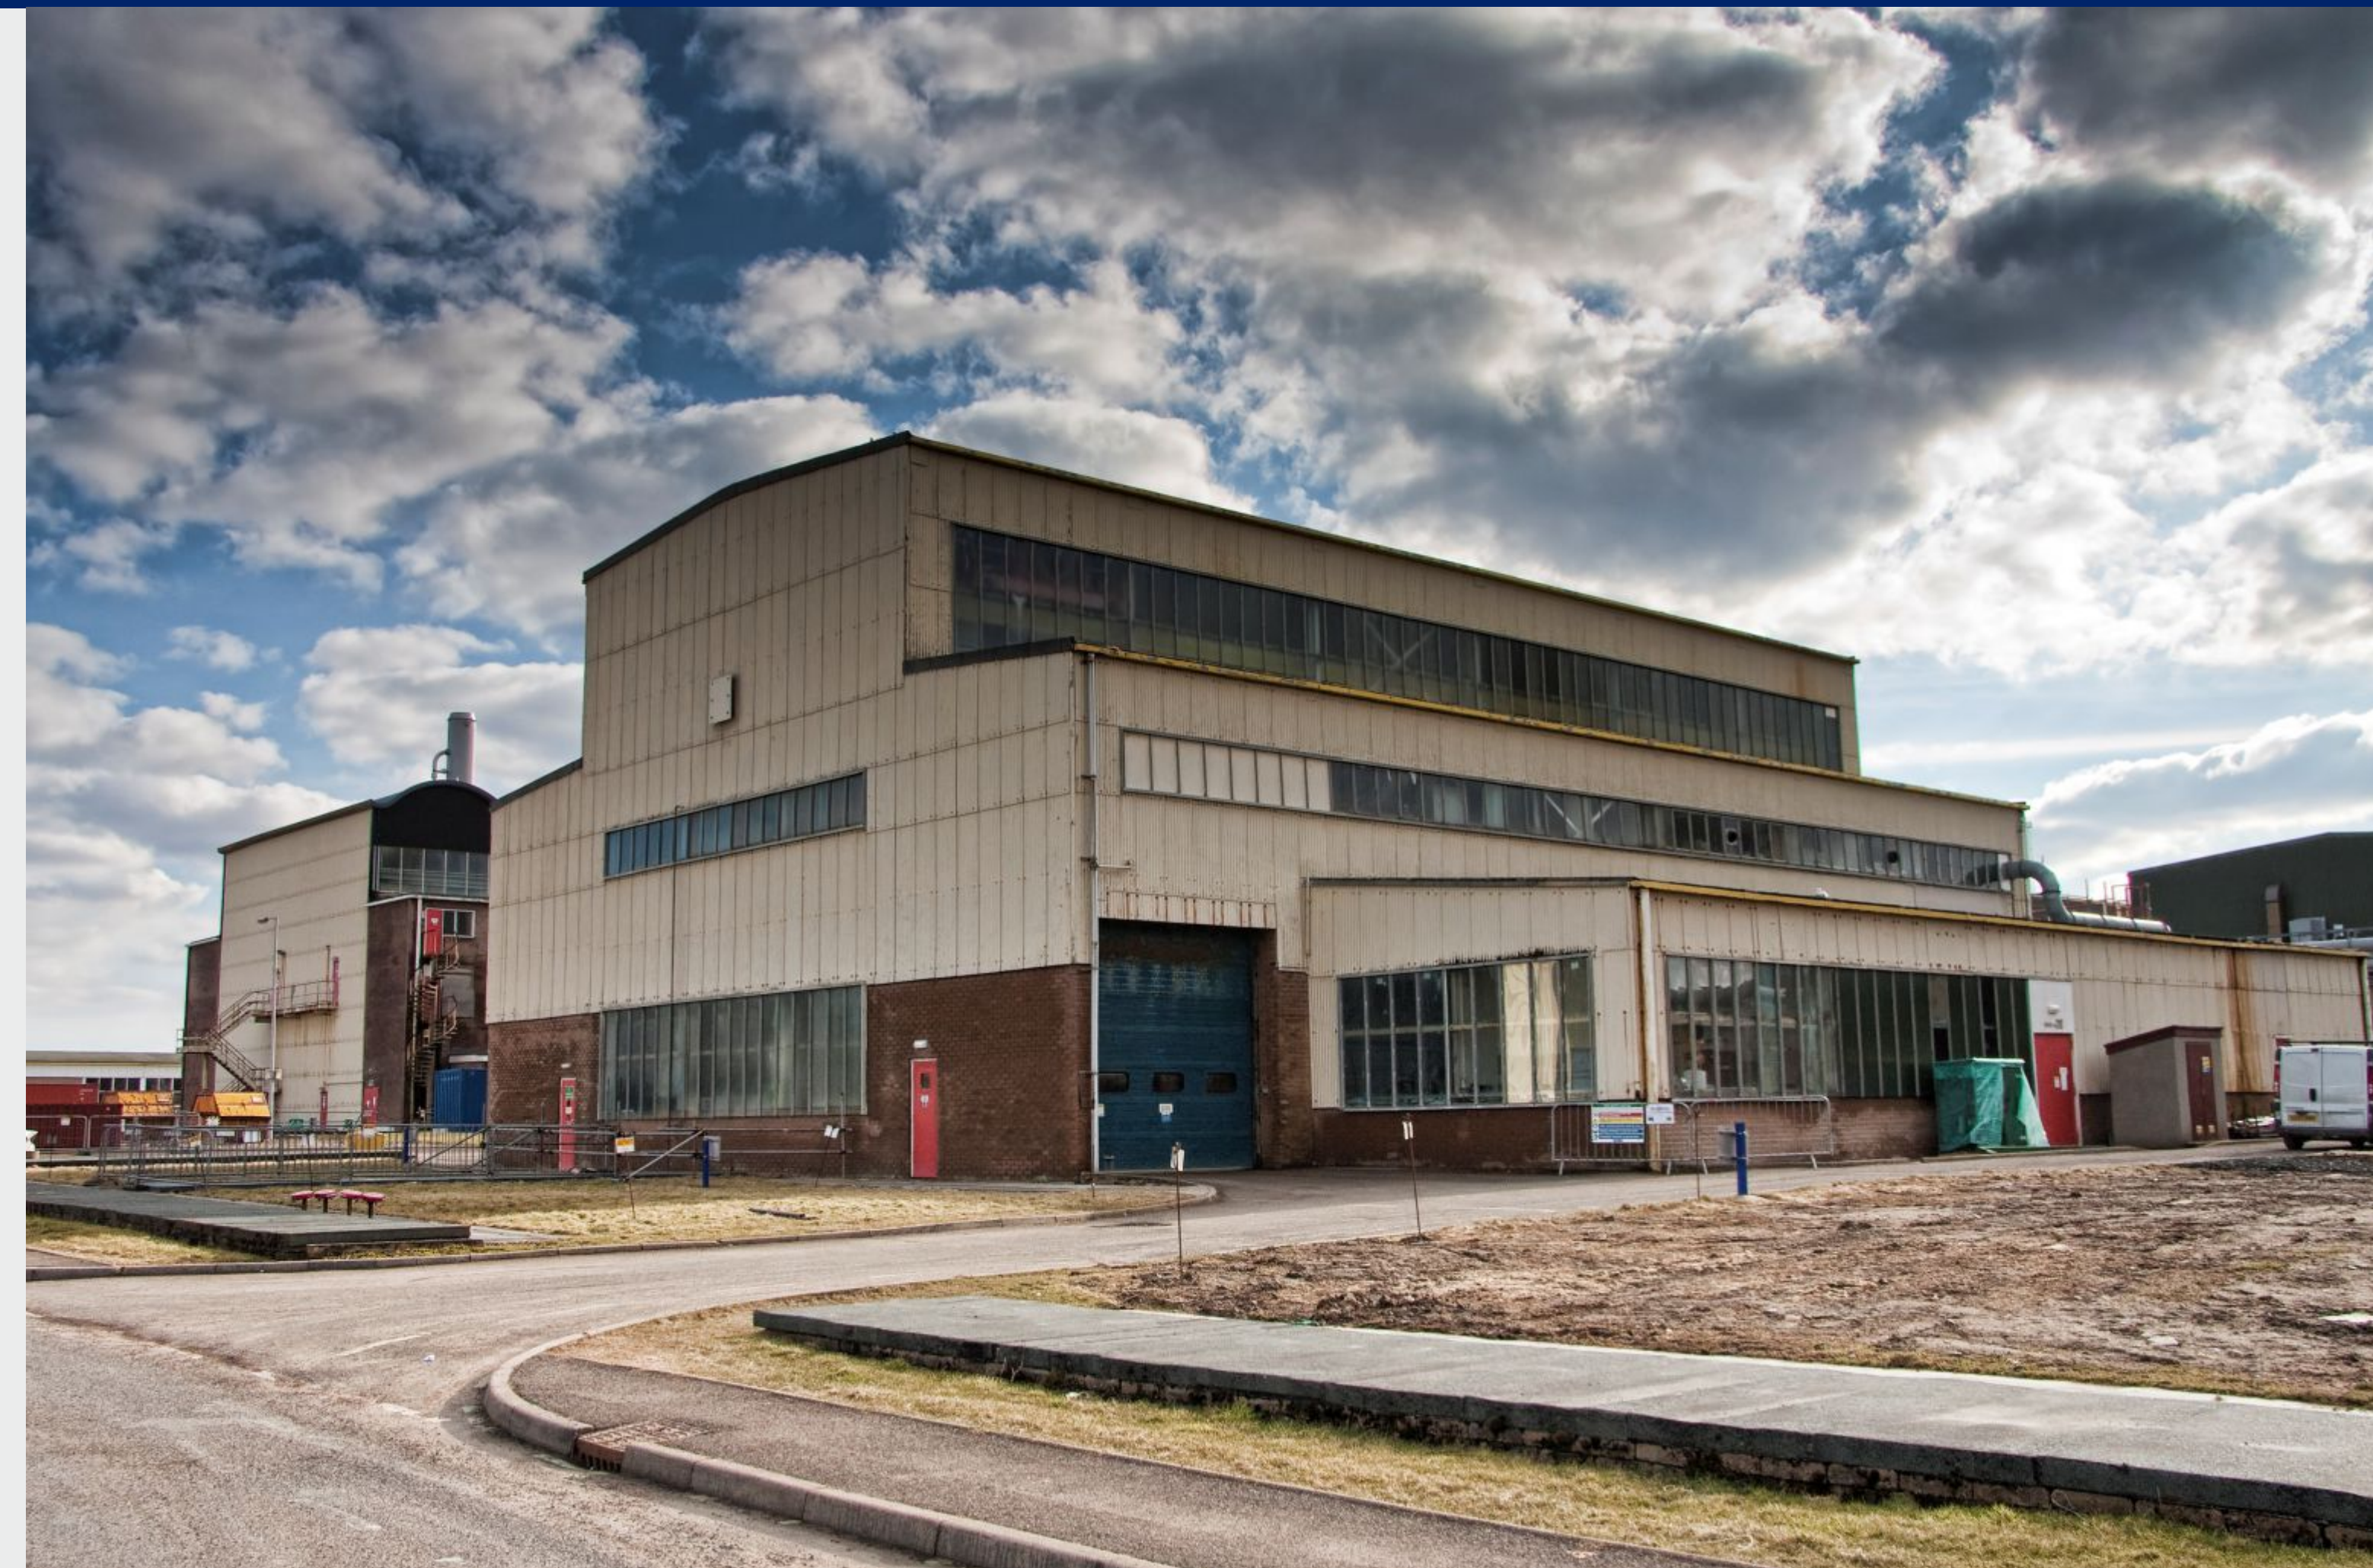
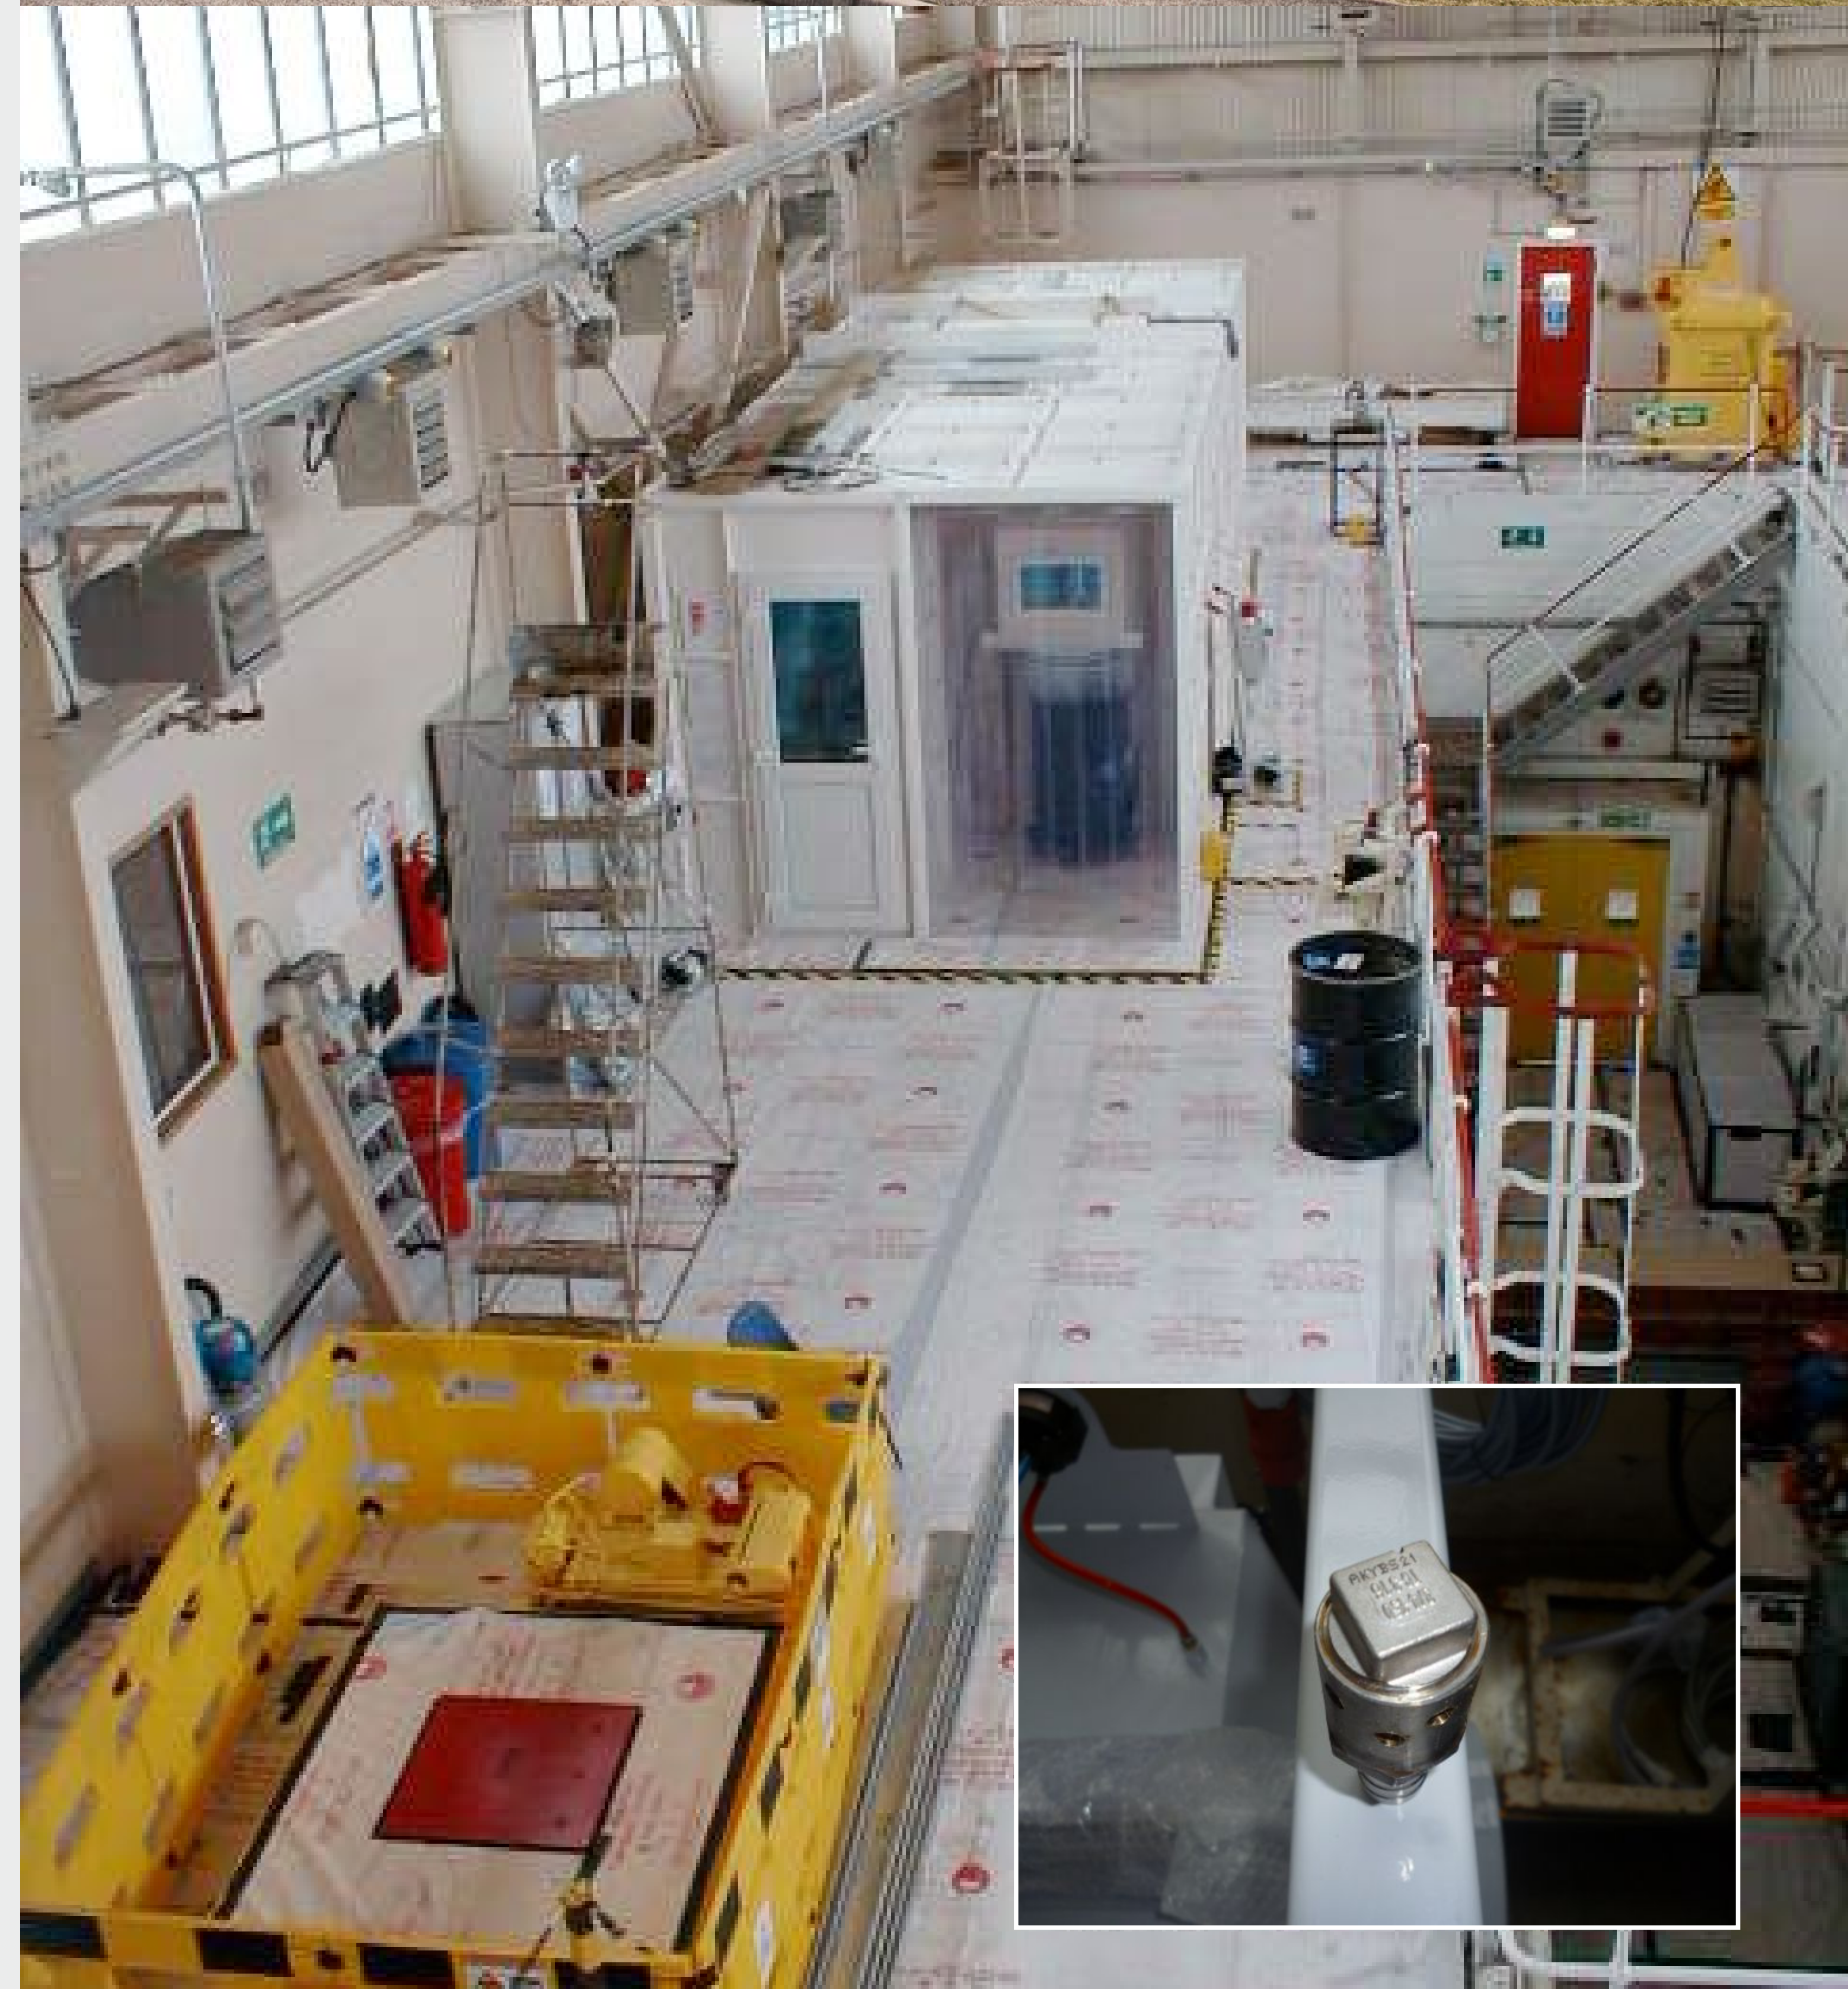
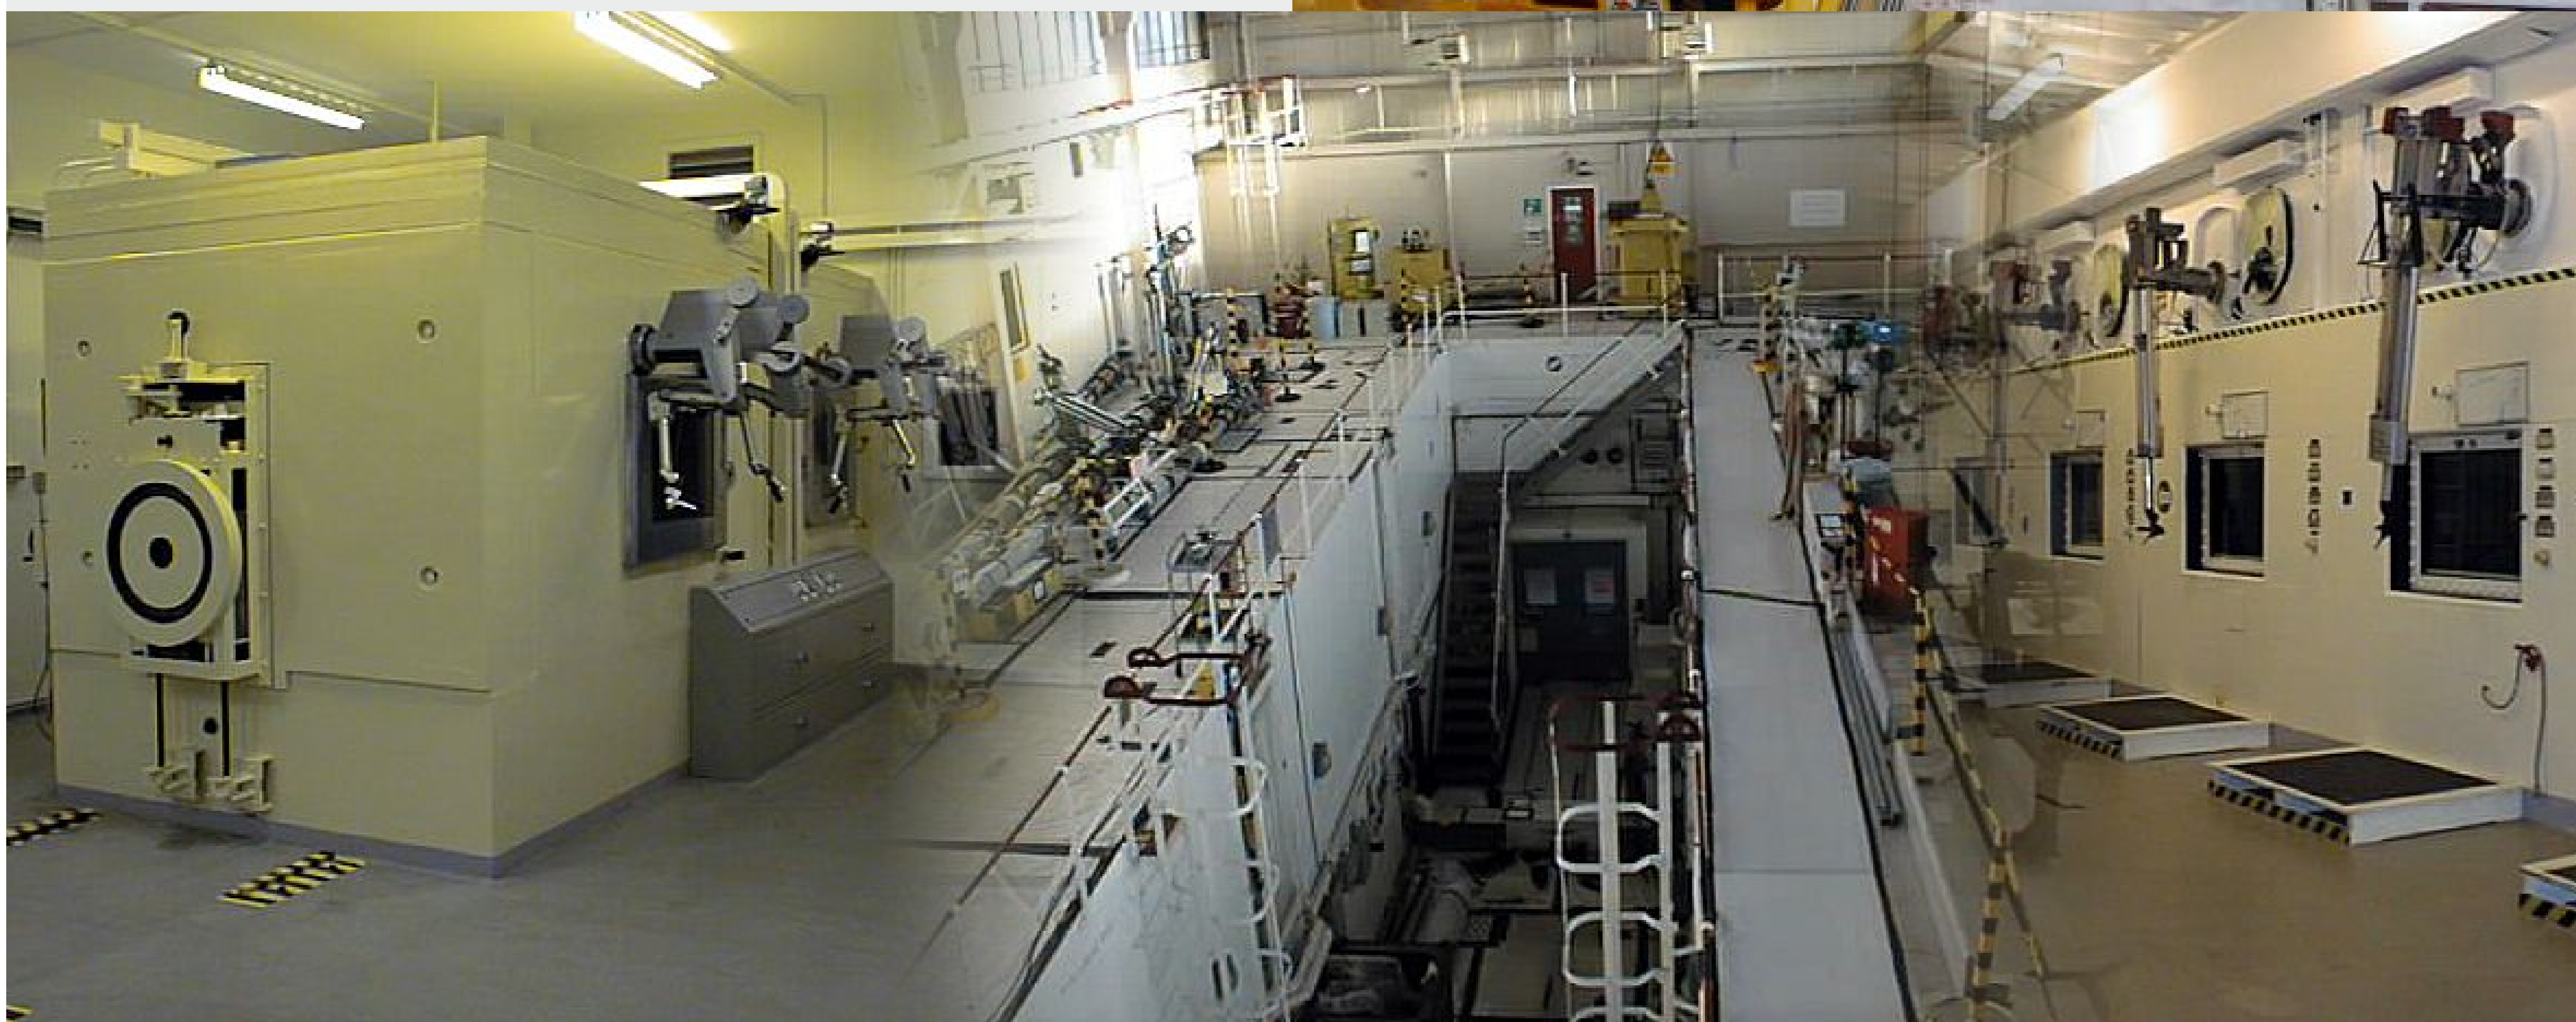
- A Zinc bromide solution has a heavier density than water.
- A new hose nozzle was created using a blank stainless steel pipe.
- The steel pipe had holes drilled all around to allow fluid to be drained from every angle.
- This weight of this additional drainage nozzle allowed the hose to sink to the bottom of the tank and remain there.
- The device was trialled successful and then the used to drain all the windows, including the windows which had a residue left in them.
- The new design resulted in only surface residues remaining in each window.
- This innovative idea was rewarded through the suggestion scheme.
