D1206 - In-cell crane repair

When the in-cell 10 cwt crane failed it had to be repaired. Man entry could not be used to repair the crane due to the high dose rates. A mock-up was made to trial ideas. The following method was successfully used.

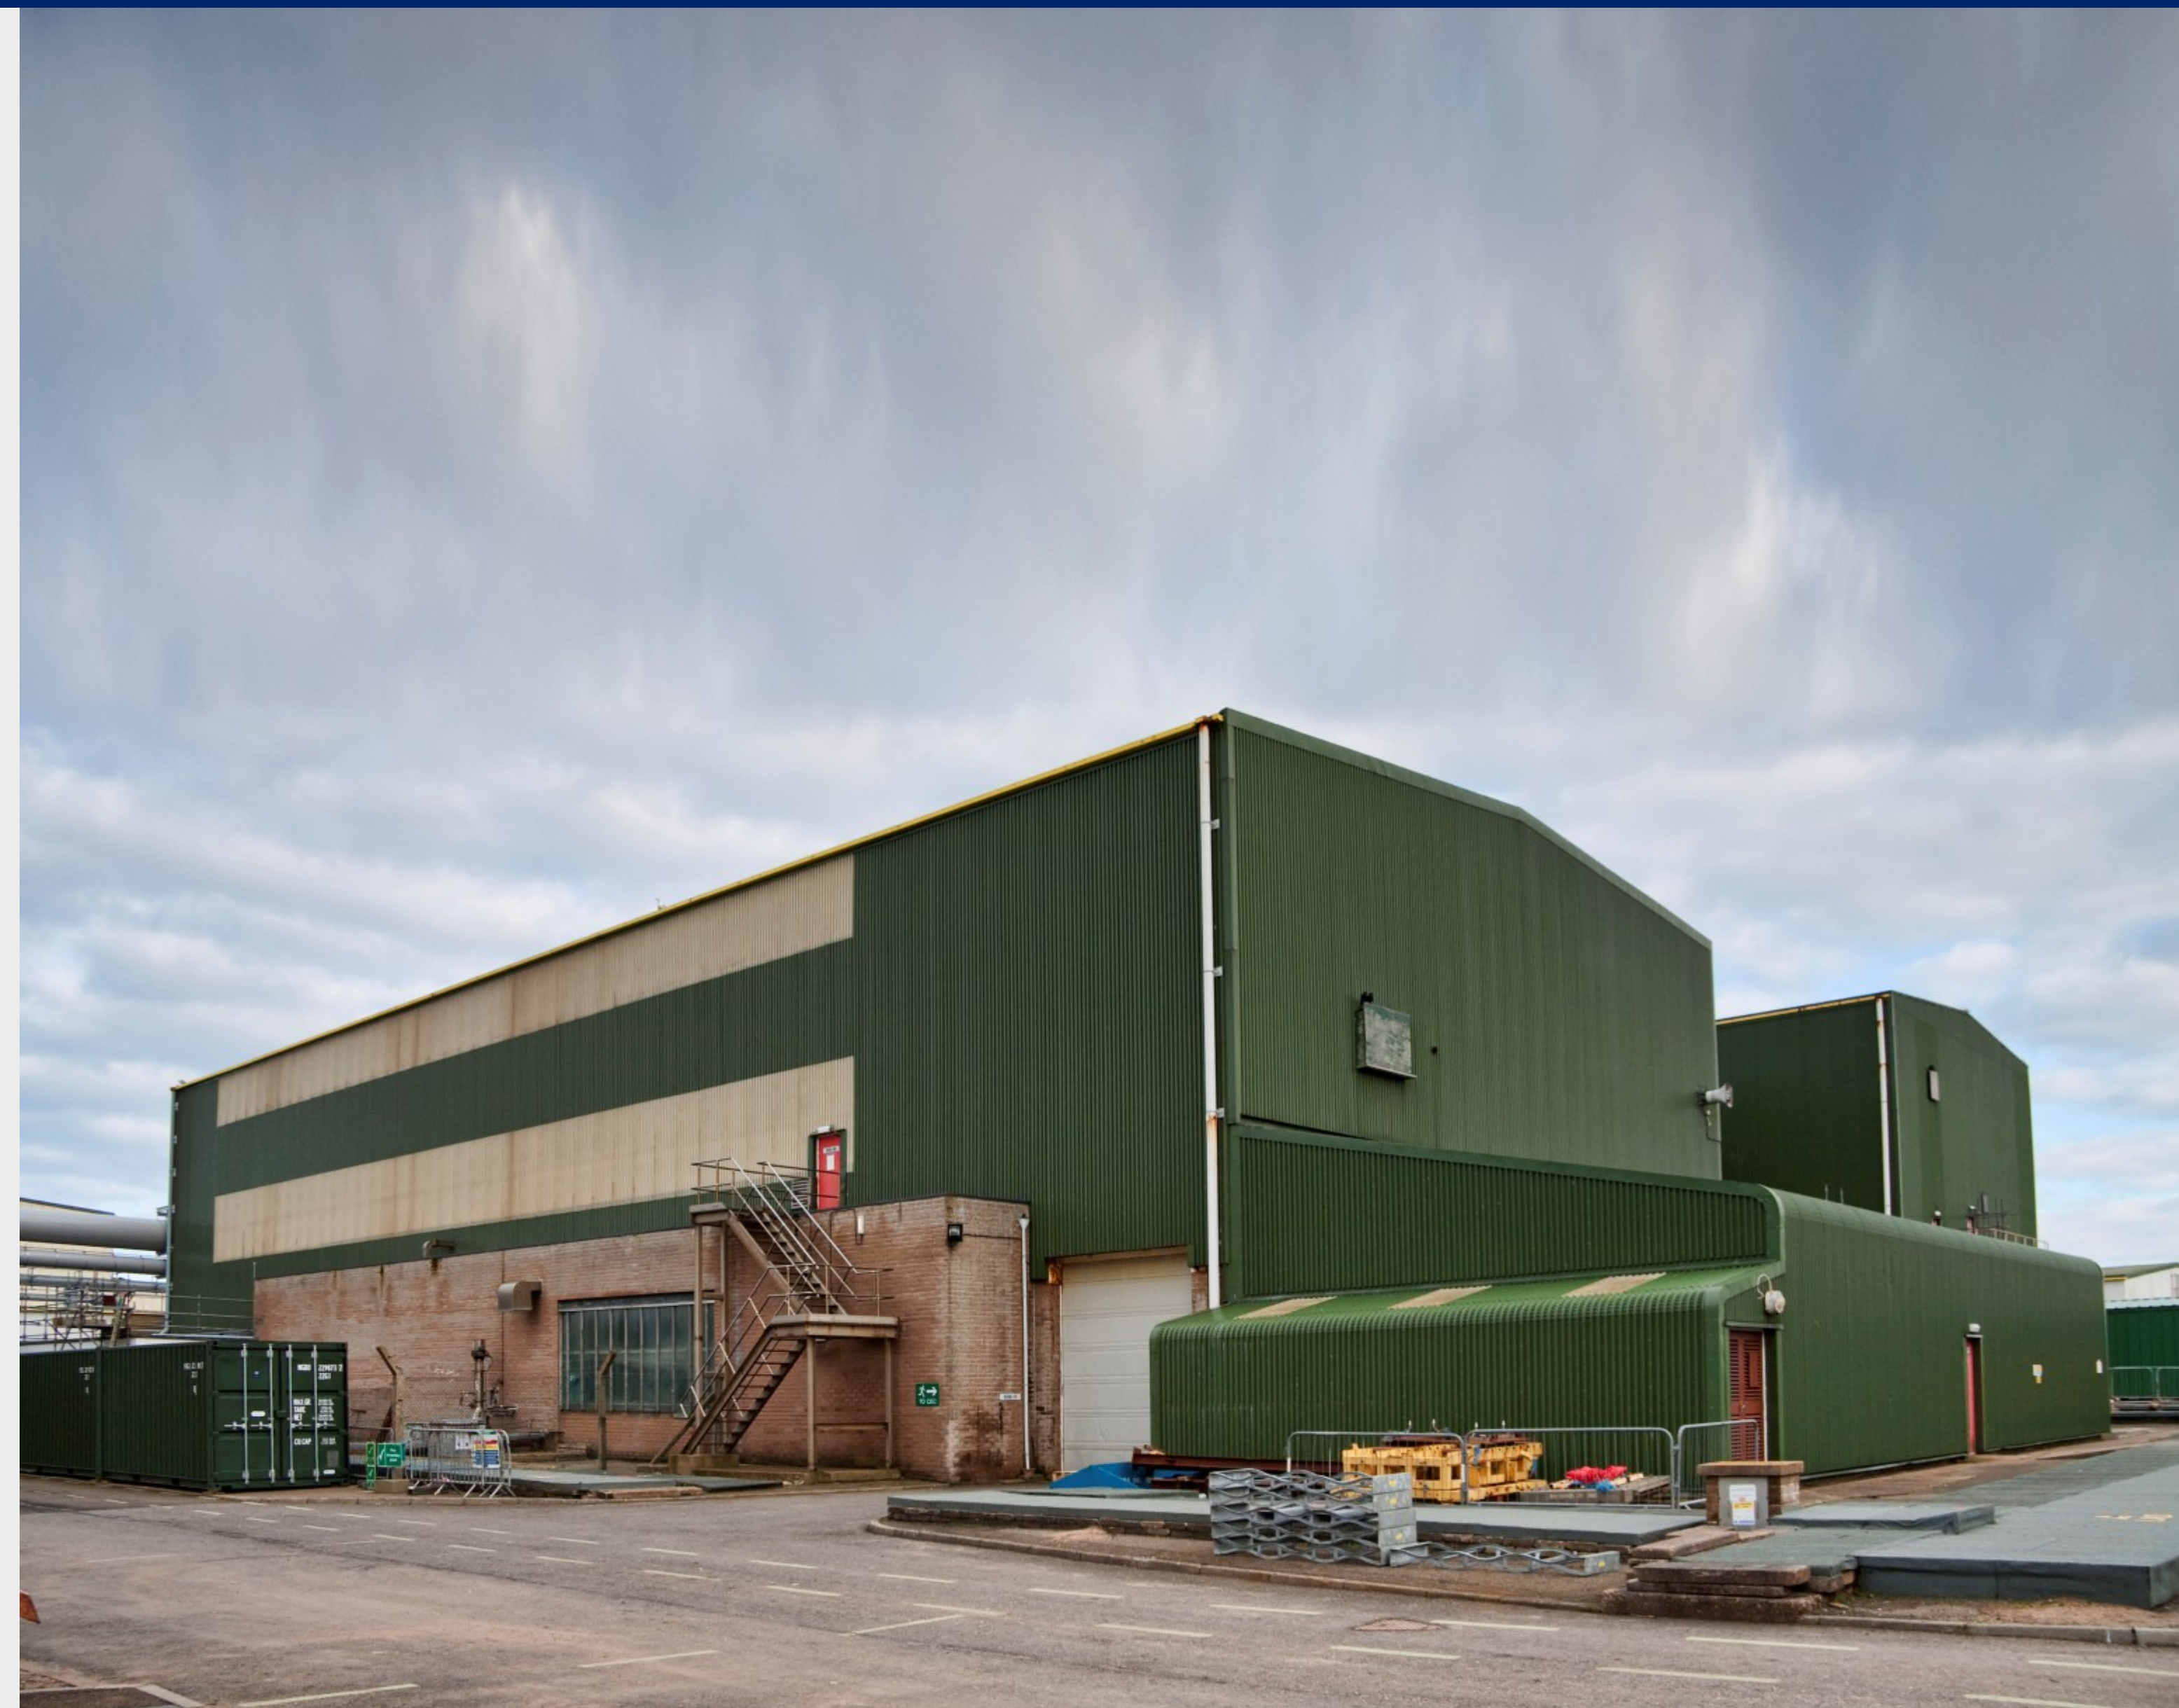
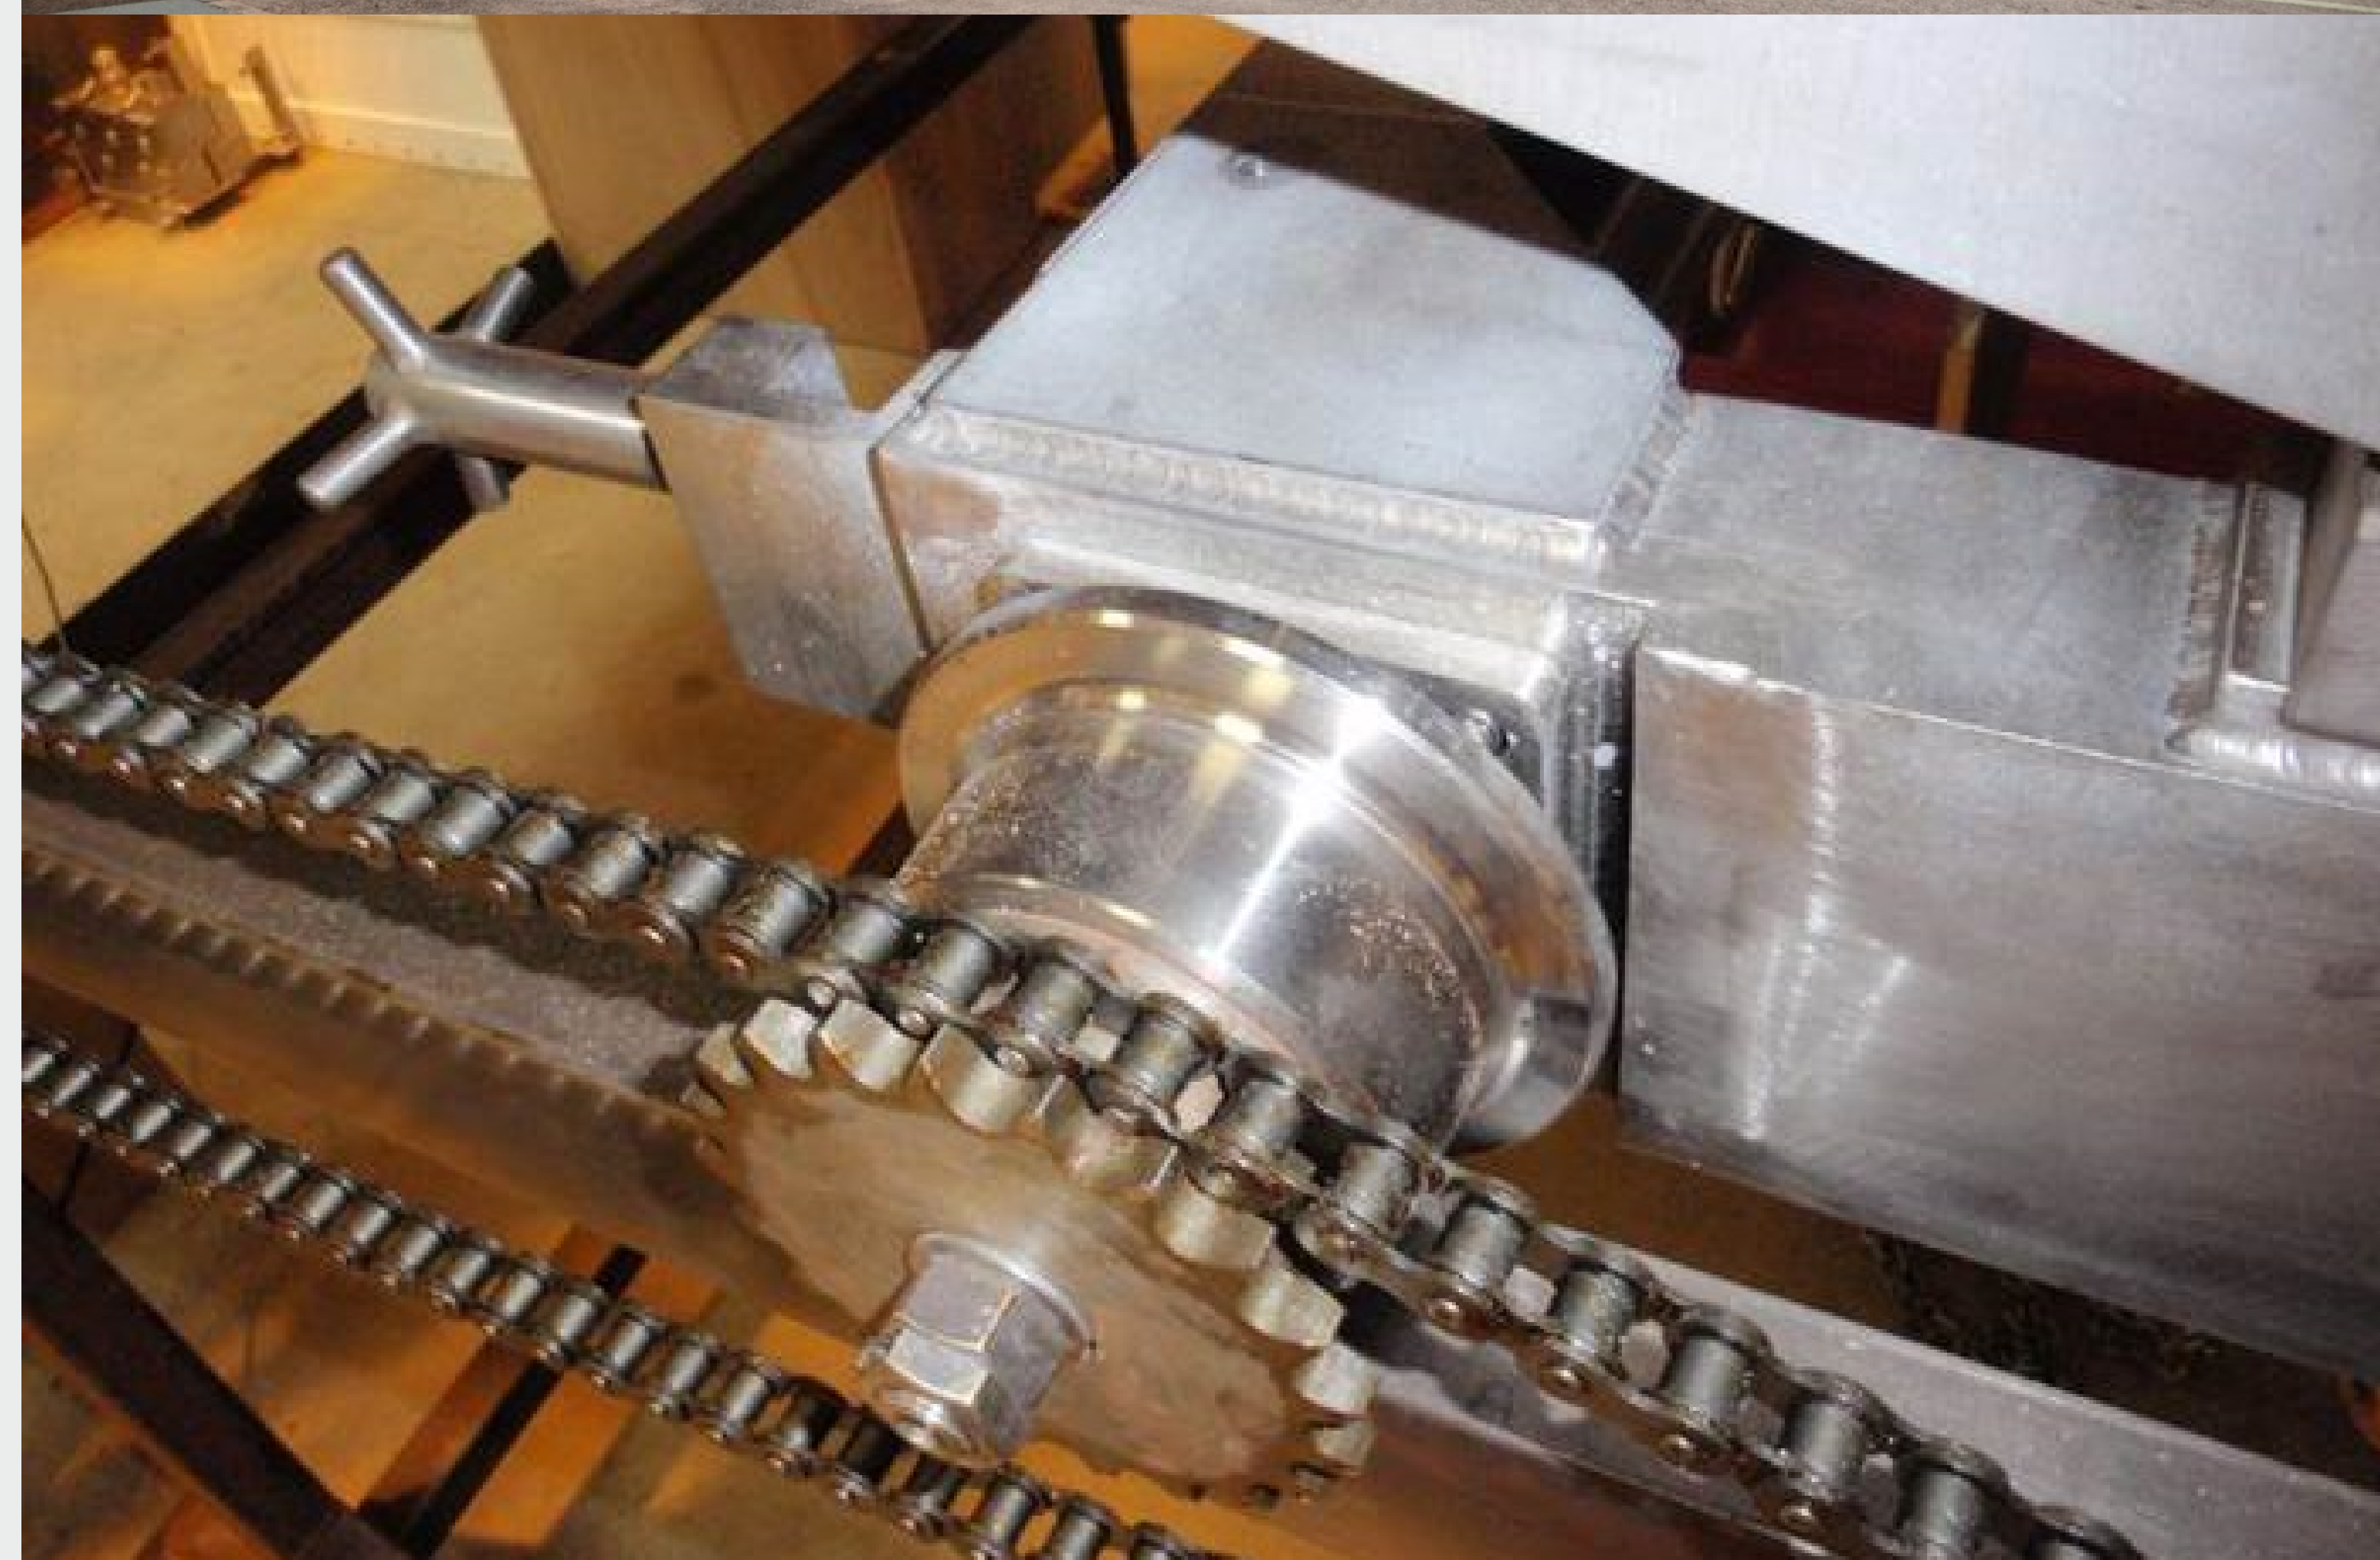
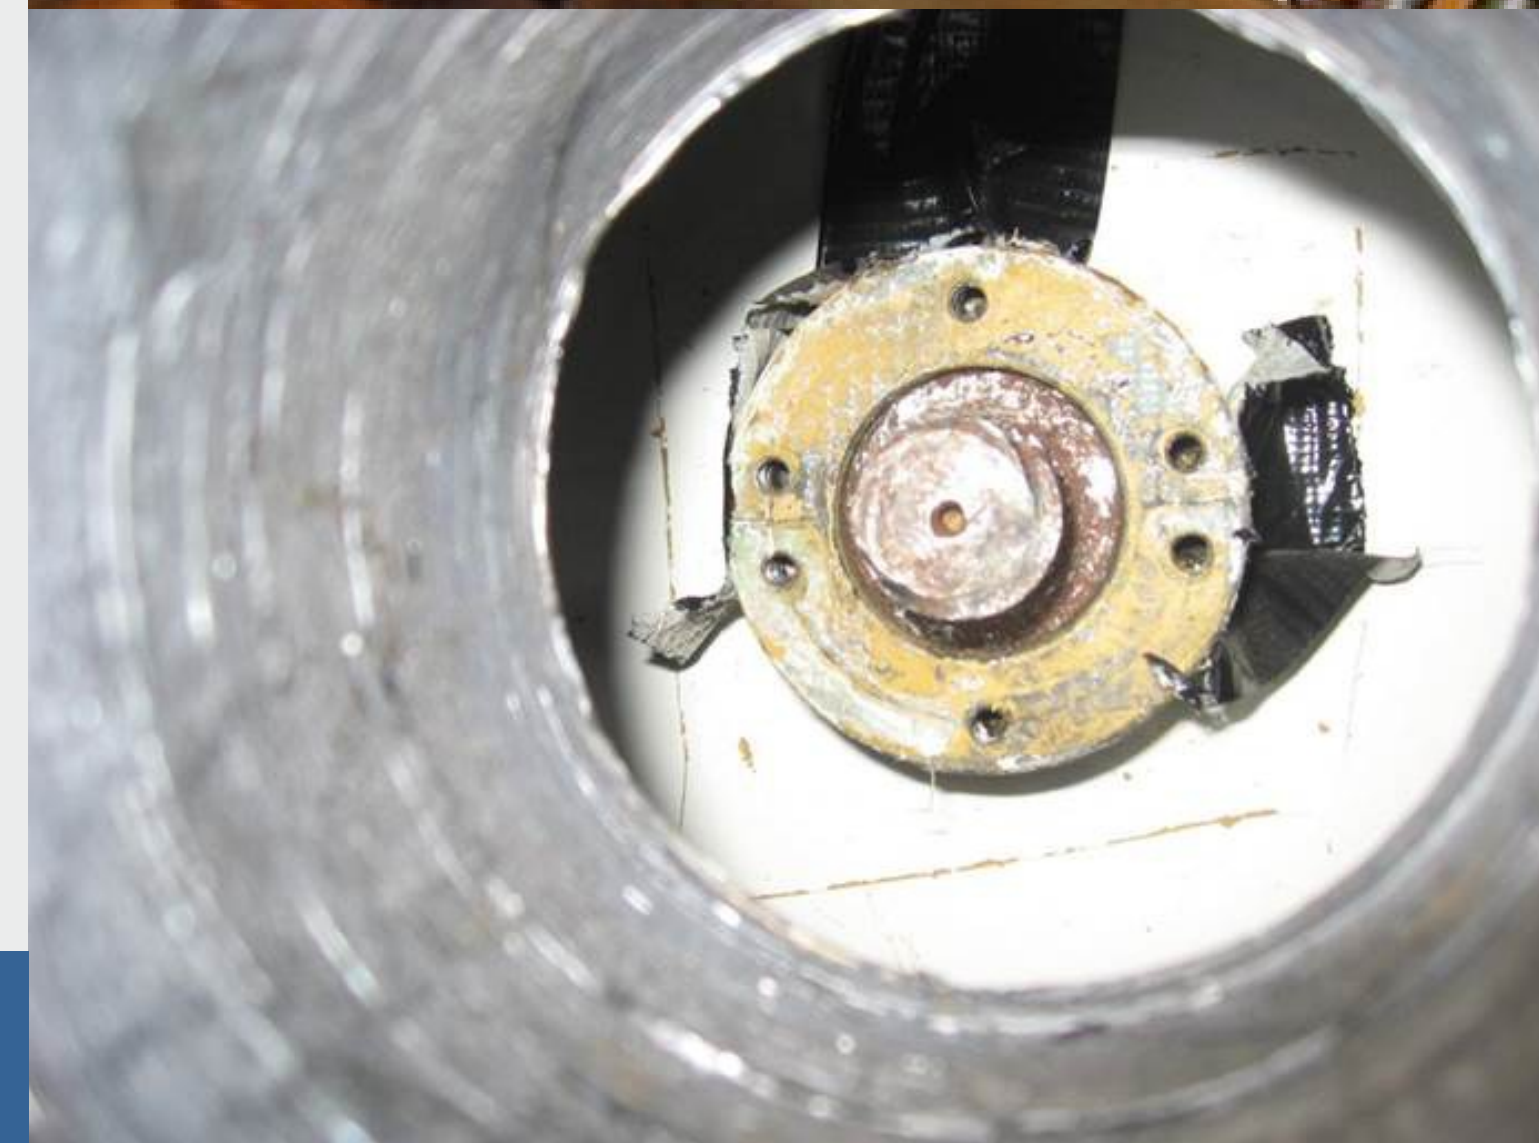
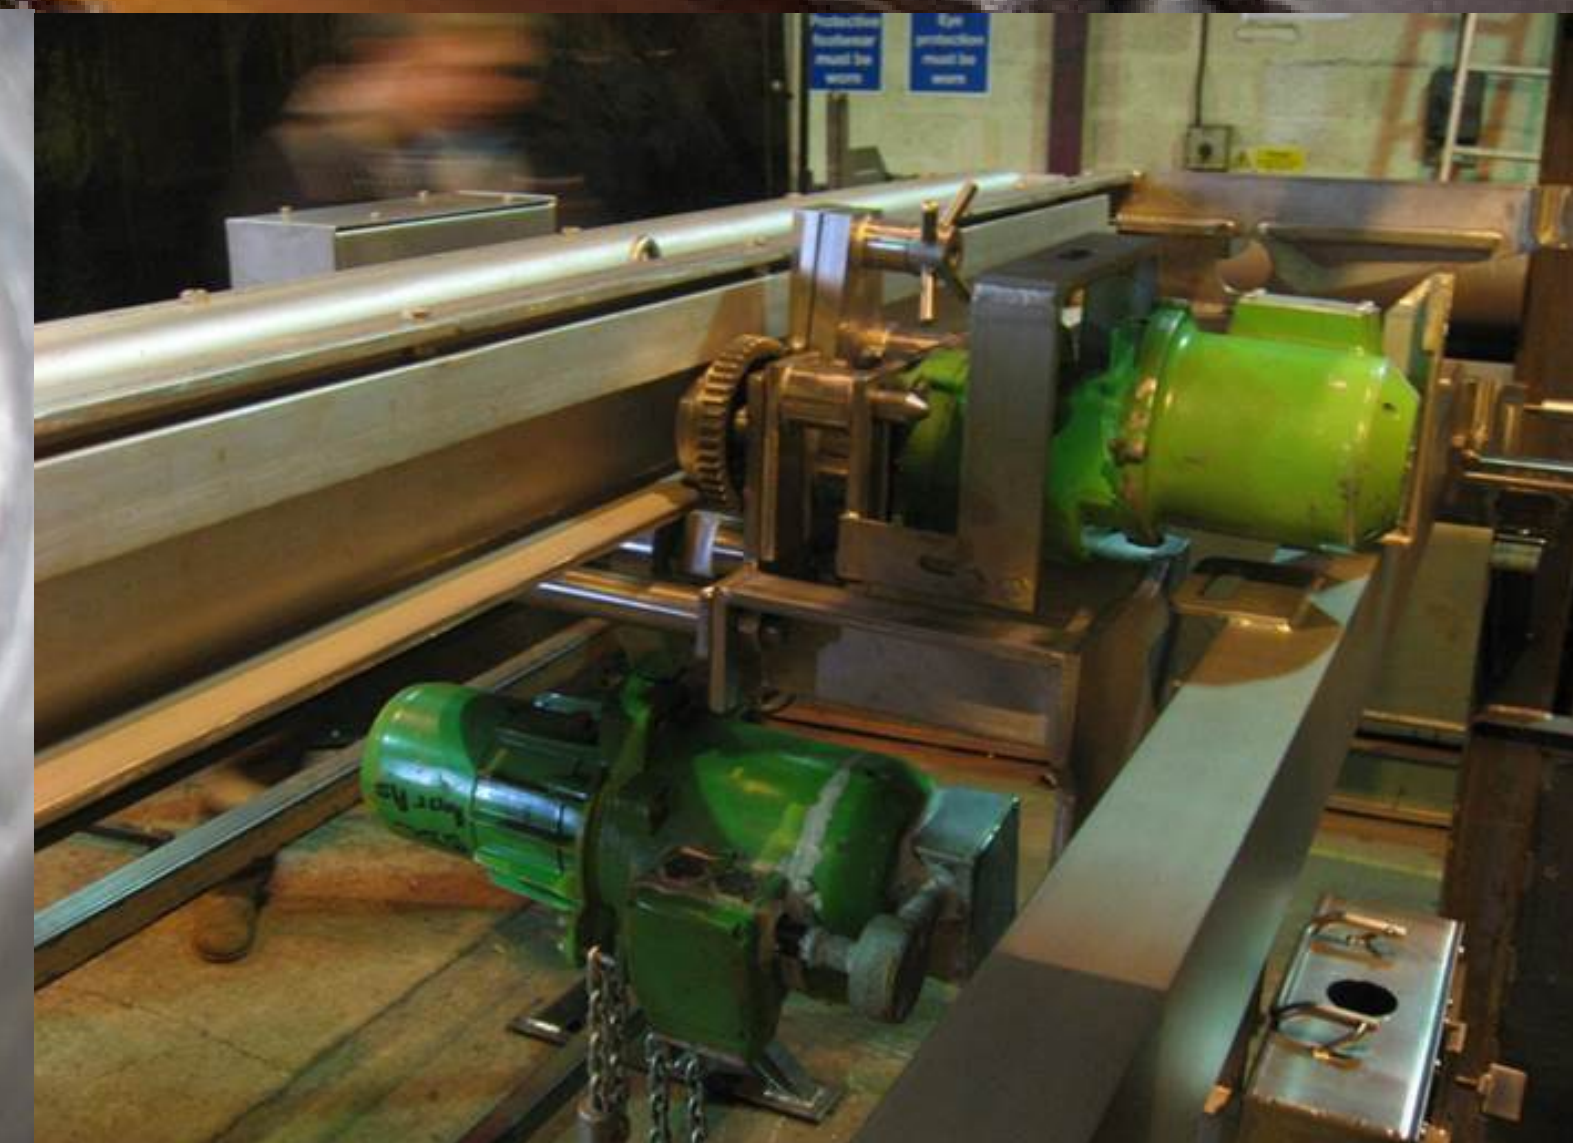
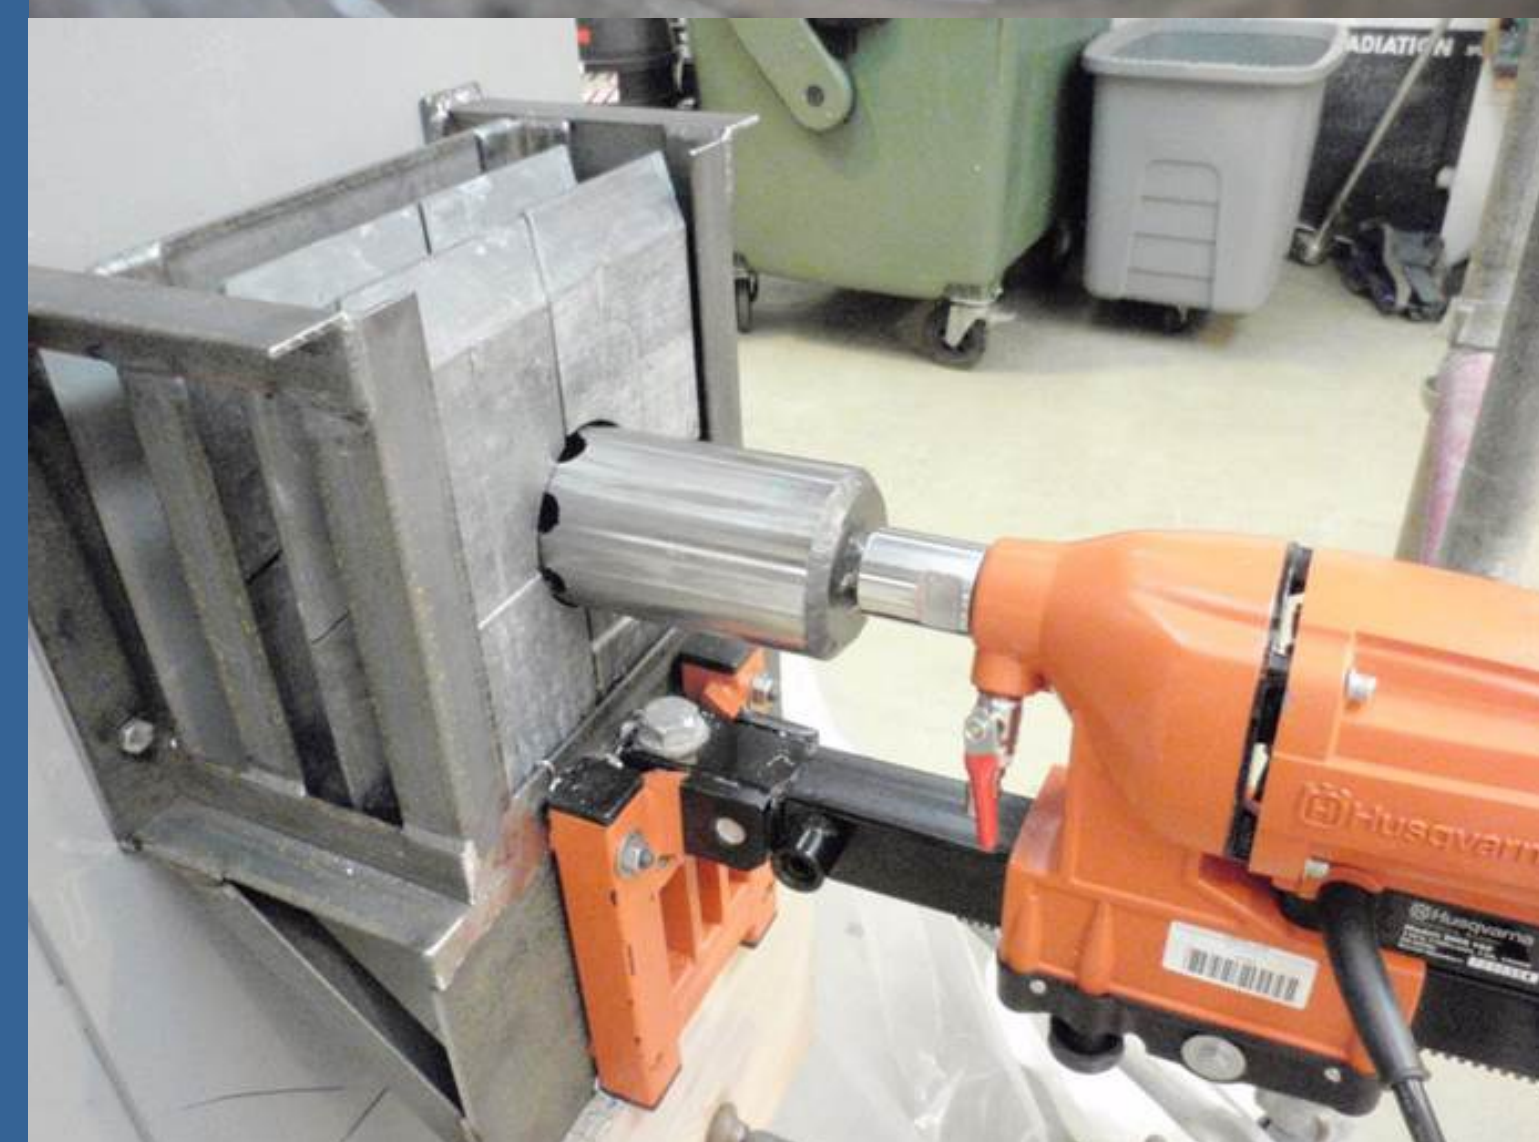
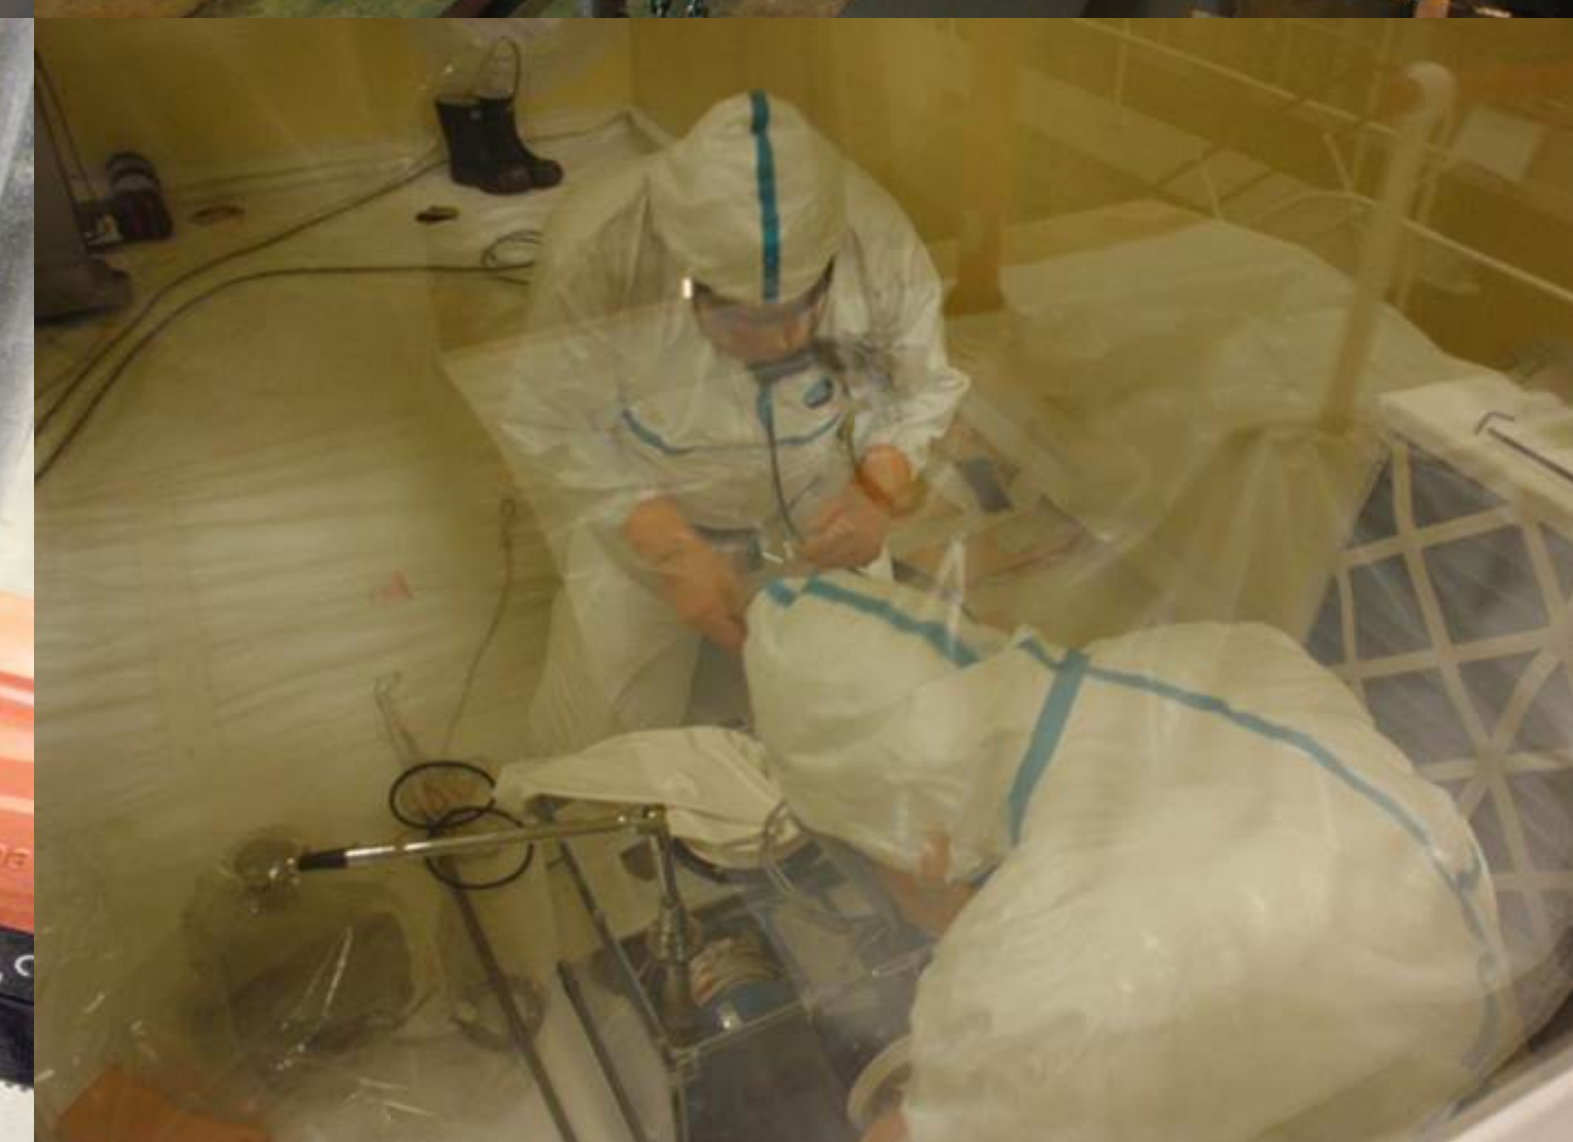
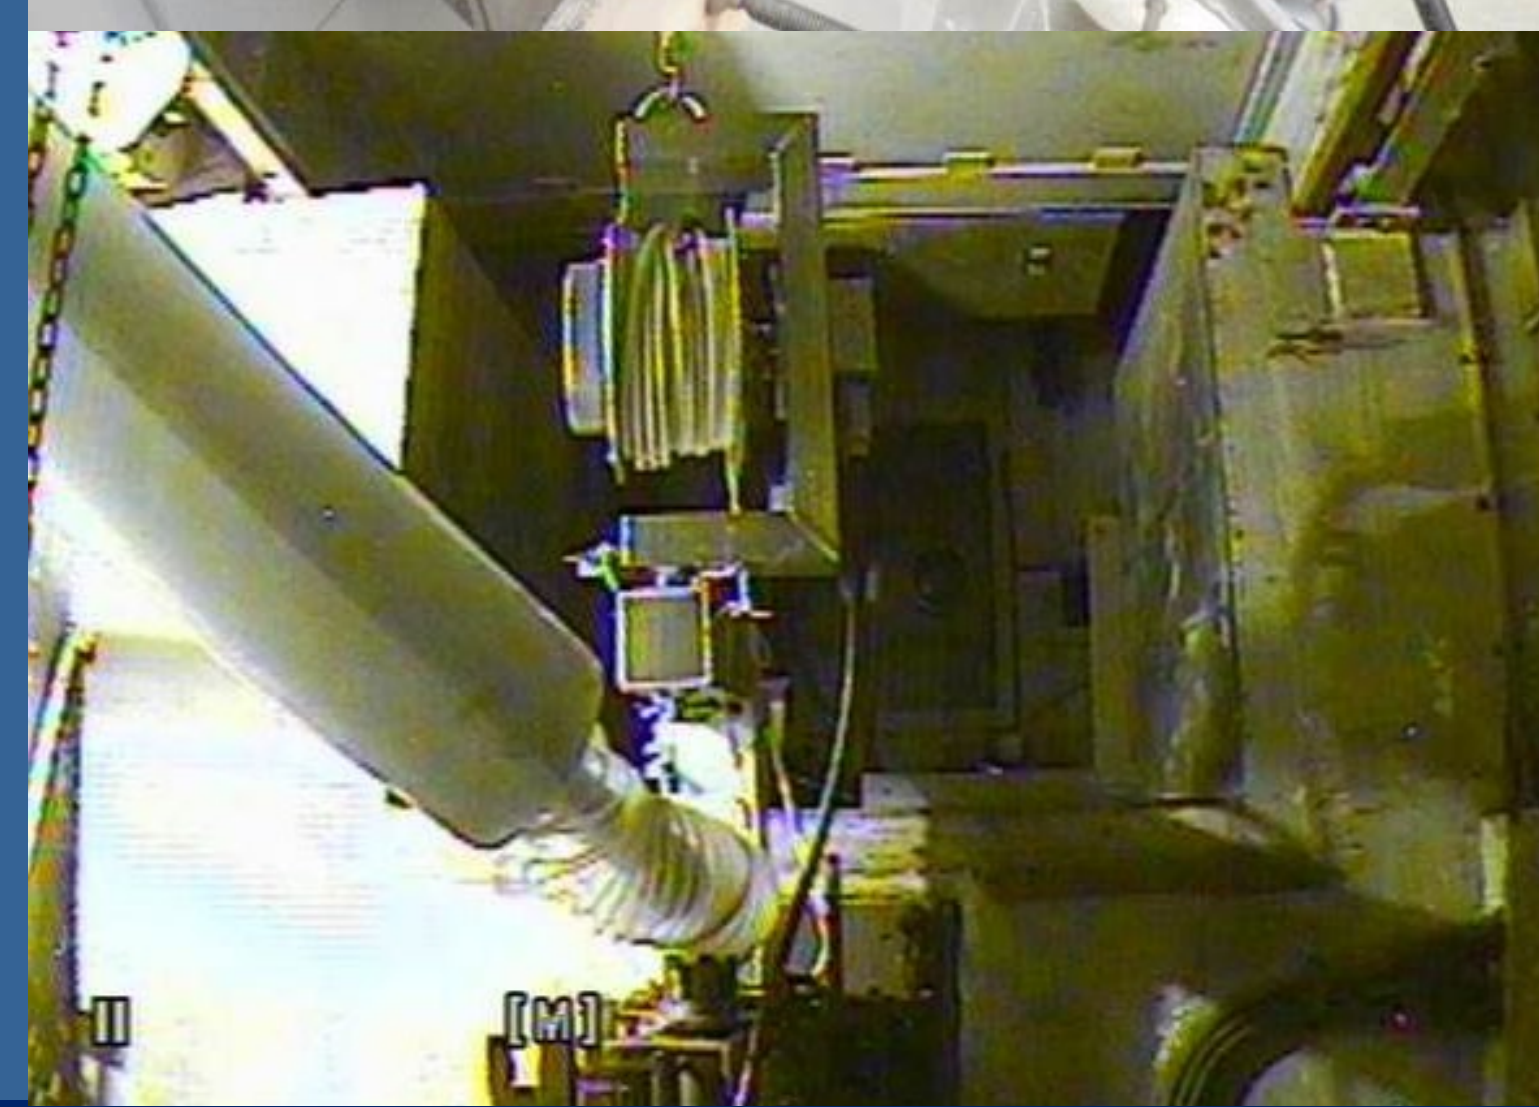
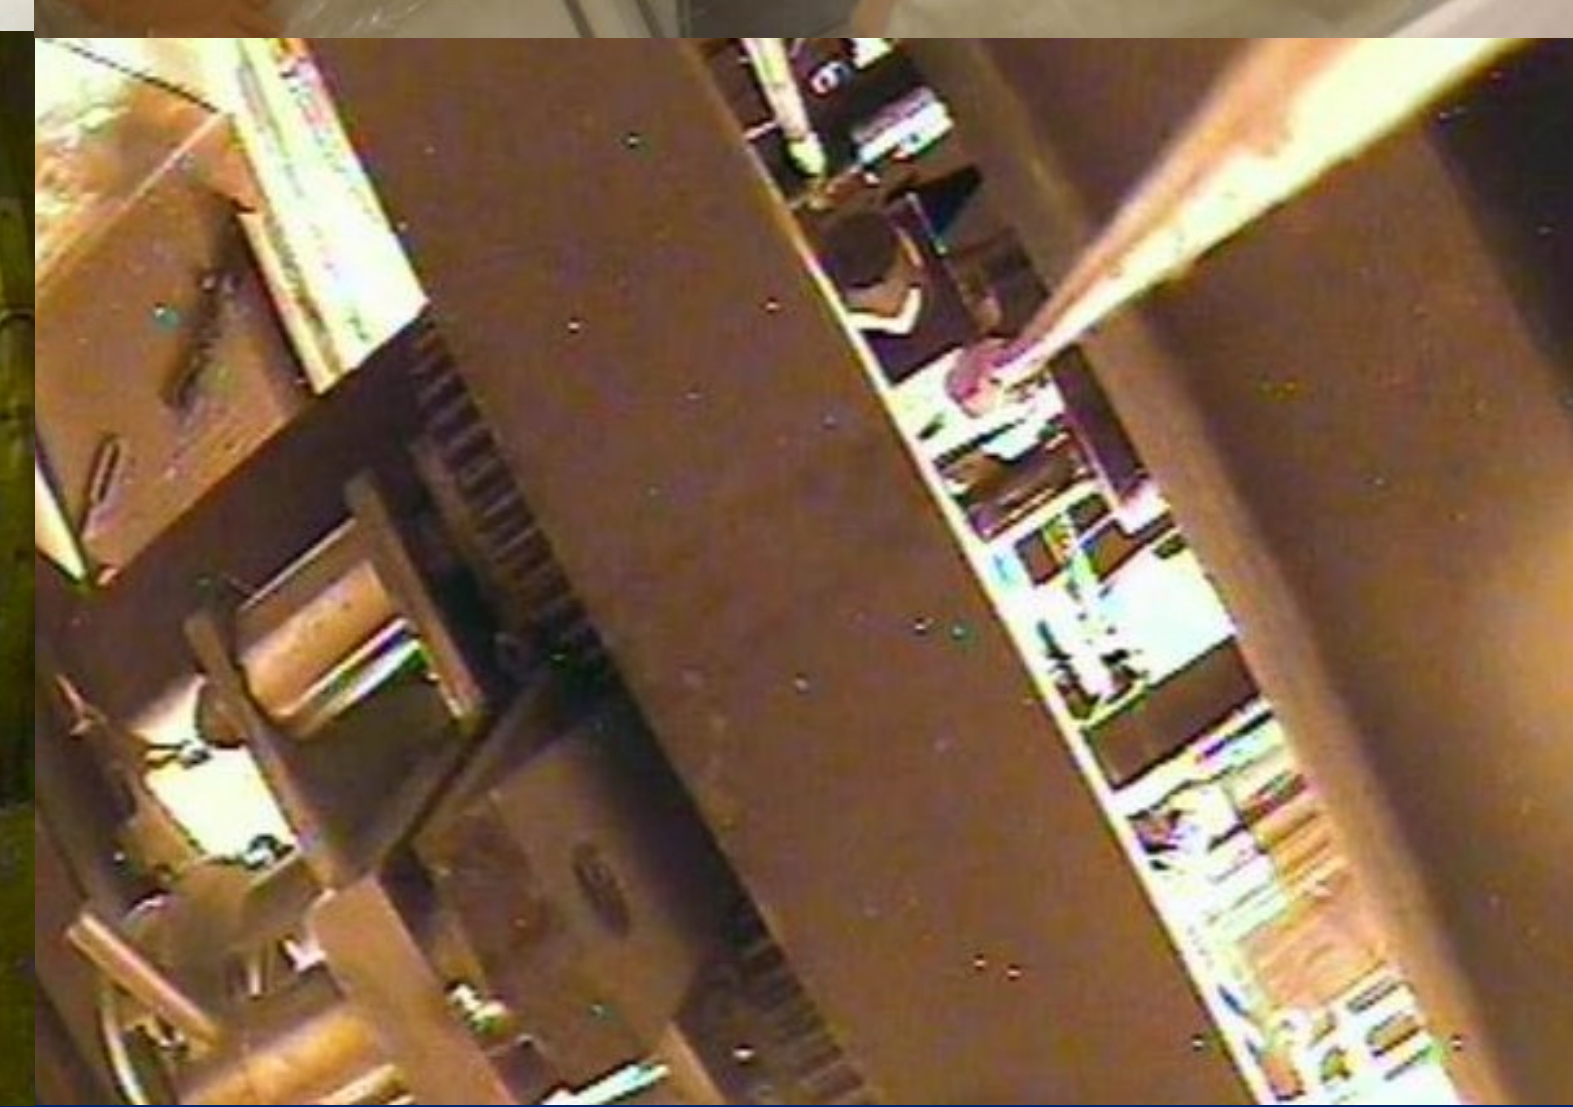
- The installed shielding was used to protect the workforce.
- A core was made through the lead shielding and a threaded collet assembly was attached to the long travel adjustment shaft.

- The crane long travel chain was re-engaged using a remote handling tool.
- The new cross travel drive was raised into position and the fitting screw operated by long reach tooling from above.

- The hoist power supplies were changed for quick release fittings allowing ready connection and disconnection in cell.
- The crane's electric hoist unit was posted into the cell and transferred down to the working area via the crane and manual hoist.

- It was raised into position using the lifting system in the roof penetration with the power supply cabling connected.
- Future repairs to the crane are now a simple and quick task
